UDSKRIFT
AF
SØ- & HANDELSRETTENS DOMBOG

DOM

S-9-14

Tryg Forsikring A/S
(advokat Jesper Windahl)
mod
DHL Global Forwarding (Denmark) A/S
(advokat Michael Villadsen)

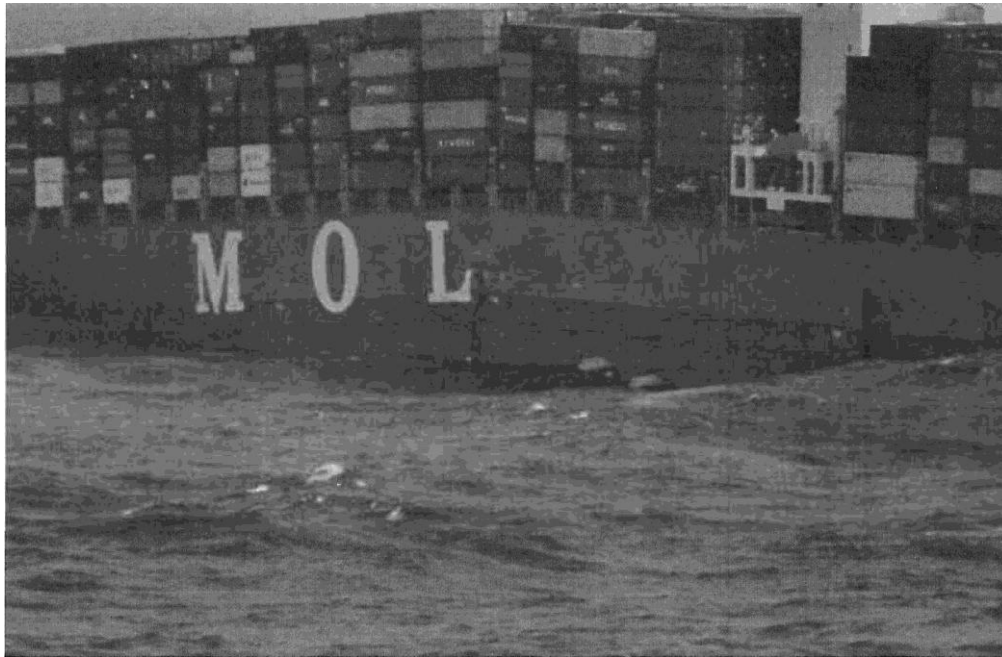
Water ingress was first detected by the water ingress alarm in the Duct Keel located near the center line of the double bottom of The Ship. Approximately two minutes later, further water ingress was detected in No.6 Cargo Hold located on the double bottom midship part. From the enlarged view in Fig. 1.3.1, the crack progression ran upwards from the bottom of The Ship, at No.6 Cargo Hold. From this, it was assumed that the crack which triggered the fracture had originated in the bottom shell plates below No.6 Cargo Hold midship part.

Fig 1.3.1 Condition of The Ship at the time of the accident
(Direction of the crack progression (photo by Mitsui O.S.K. Lines, Ltd)

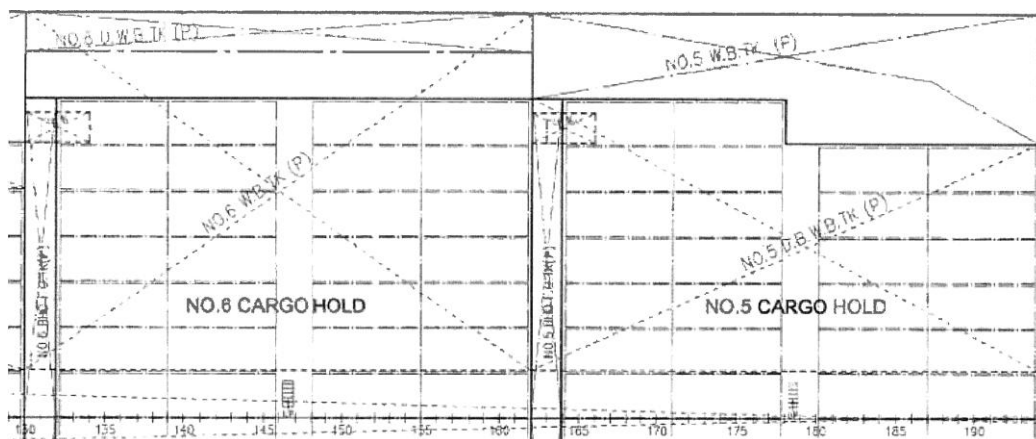
Fig 1.3.3 Tank Top Arrangement of No.5 & No.6 Cargo Holds (Port Side)

showed buckling deformations in bottom shell plates on both the port and starboard sides near the butt joint in the vicinity of Fr.182 under No.5 Cargo Hold locating one-hold forward. Some similar deformations were recorded after 4 January 2010. Since no repairs were recorded, such deformations may exist in The Ship. In addition, there are no records regarding buckling deformations in the bottom shell plates during the periodic dry-docking surveys by the classification society. ...

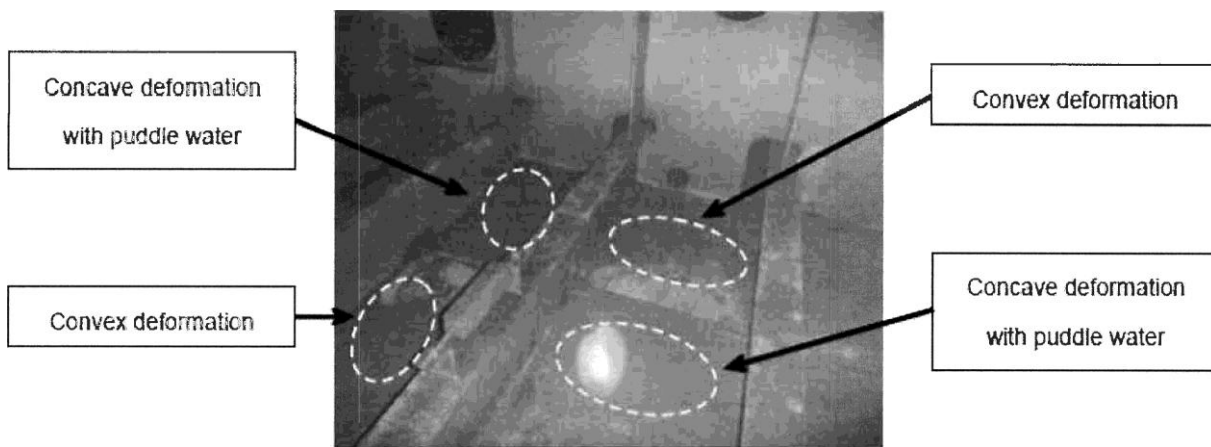
Fig 1.4.1 Example of buckling deformations observed in the bottom shell plates in double bottom midship part found on The Sister Ship operated by the same operator of The Ship (photo by Mitsui O.S.K. Lines, Ltd.)

Fig. 1.4.1 shows an example of deformation observed in The Sister Ship operated by the same operator of The Ship. The concave and convex buckling deformation of the bottom shell plates were observed between the bottom longitudinal stiffeners which were not deformed.

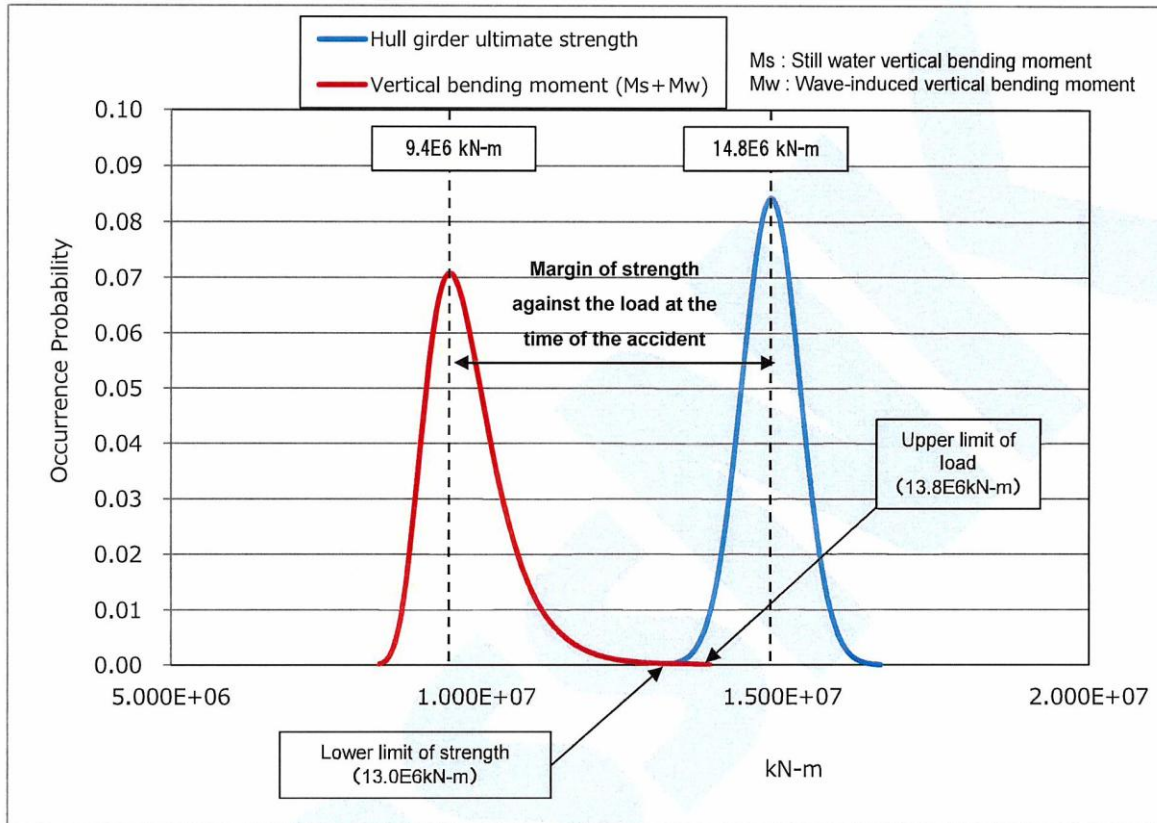
In **Fig. 3-1**, the size of the overlapping part between the blue curve which shows the probability of the strength and the red curve which shows the probability of the load indicates the qualitative level of occurrence probability of the fracture. Therefore it can be said that the following two factors are important to investigate the possibility of occurrence of the fracture:

Fig. 3-1 Relationship between strength and load at the time of the accident
(Probability distribution curve of strength and load)
