UDSKRIFT
AF
SØ- & HANDELSRETTENS DOMBOG

DOM

S-9-14

Tryg Forsikring A/S
(advokat Jesper Windahl)
mod
DHL Global Forwarding (Denmark) A/S
(advokat Michael Villadsen)

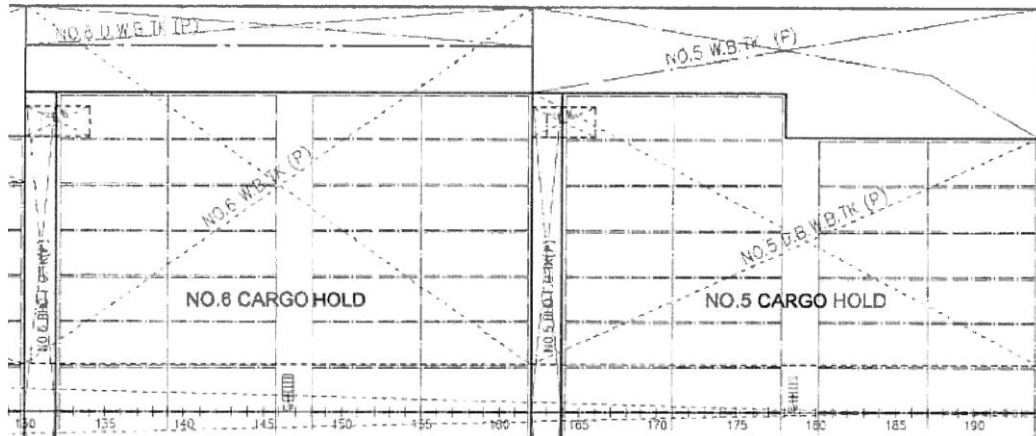
Tank Top Arrangement of No.5 & No.6 Cargo Holds (Port Side)

The Ship experienced hogging (convex deformations in the longitudinal direction), causing the ship's midship to fracture. According to observation of the progression following the outbreak of the accident, the upper deck area was the last part to fracture. From this, it can be assumed that the crack which triggered the fracture began below the waterline in the bottom part of the ship's hull and then progressed upwards along the side of the ship. The fracture is believed to have originated in the bottom shell plates of No. 6 Cargo Hold.

An investigation of The Ship's maintenance and inspections records also found buckling deformations on the bottom shell plates of the No. 5 Cargo Hold forward of the presumed fracture point.
